## PROPERTY INSPECTION REPORT

**Concerning: 1234 Anystreet Houston, TX**

**By: S. Robert Hill, Professional Inspector TREC # 5665**

**Date: 11/08/2007**

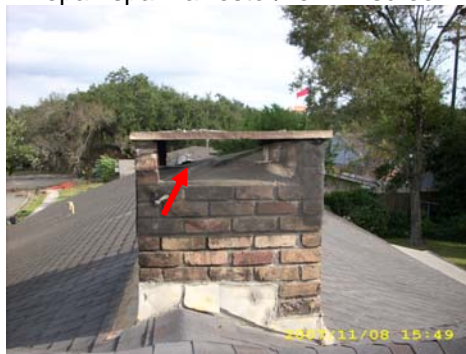
- Repair spark arrestor/vermin screening at roof level.

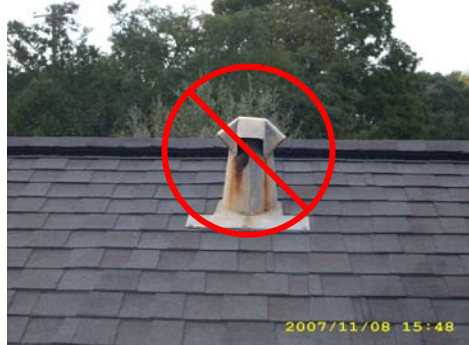
- Flame(s) observed for color and pattern. Unit(s) tested for evidence of carbon monoxide and gas leaks and are considered serviceable unless otherwise noted.
- Vent termination assembly does not meet current standards.

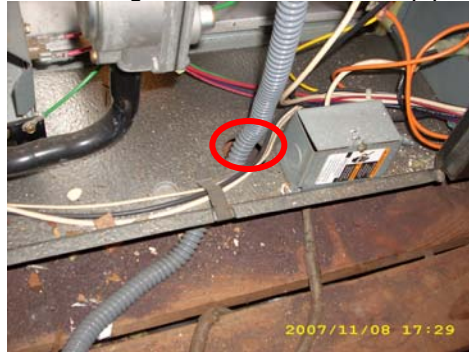
- The flex gas line should be hard piped at the point of entry at the gas furnace.

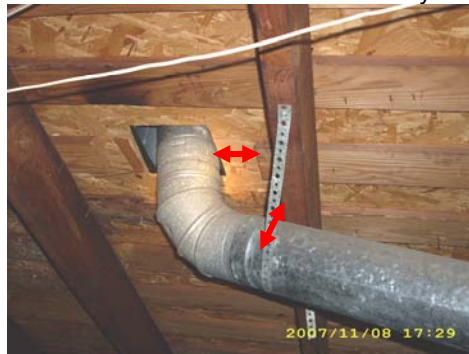
- The blower has slight vibration which should be further evaluated when servicing is performed.
- The vent pipe requires a minimum 1-inch clearance from combustibles. The roof deck should be trimmed away and/or the vent pipe adjusted as necessary.

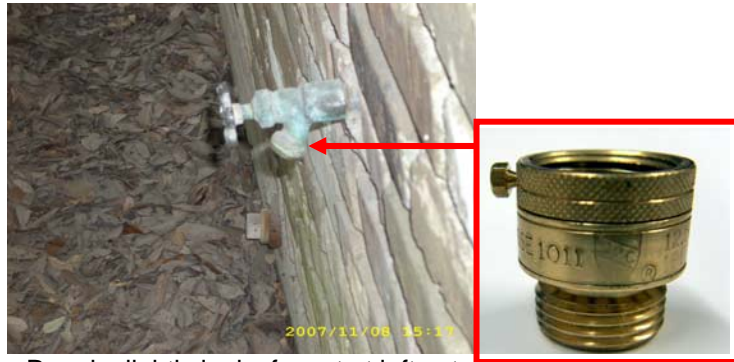
- Type: Galvanized and copper supply lines. NOTE: although most of the galvanized piping appears to have been replaced, some likely still exists and older steel piping is subject to corrosion on the interior of the pipe. As corrosion builds up, the inside diameter of the pipe becomes constricted, resulting in a loss of water pressure. This piping is typically replaced when the loss of pressure can no longer be tolerated.
- General Information: Main shut off location: front exterior
- It is recommended that an anti-siphon device be added to the hose bib(s). This is a small device that attaches to the outside hose connection to prevent water contamination.

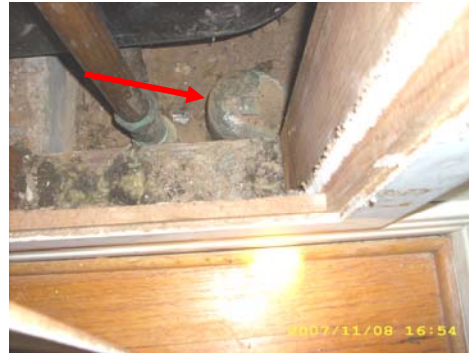
- Type: For the most part, the drain/waste piping within the house appears older. It may be prone to unexpected problems. Improvement is recommended on an as needed basis. NOTE: A PVC cleanout was observed at the rear exterior, indicating that previous repairs have been undertaken.
- The bathtub was observed to drain slowly, suggesting that an obstruction may exist, likely due to the old drum trap. It may be desirable to replace the drum trap with a "P" trap. A qualified plumber should be consulted.

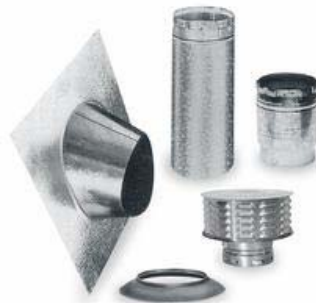
- Exterior closet: 40 gallon gas water heater (6 years old)
- Vent termination assembly does not meet current standards.

- Maintain 1-inch vent clearance from combustibles (i.e. sheetrock).

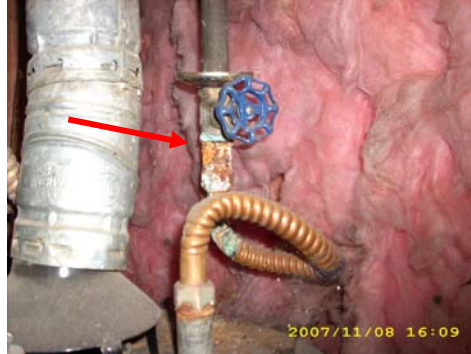
- Corrosion observed on cold supply should be repaired (clean or replaced) as necessary.
