## PROPERTY INSPECTION REPORT

**Concerning: 1234 Anystreet Houston, TX**

**By: S. Robert Hill, Professional Inspector TREC # 5665**

**Date: 11/08/2007**

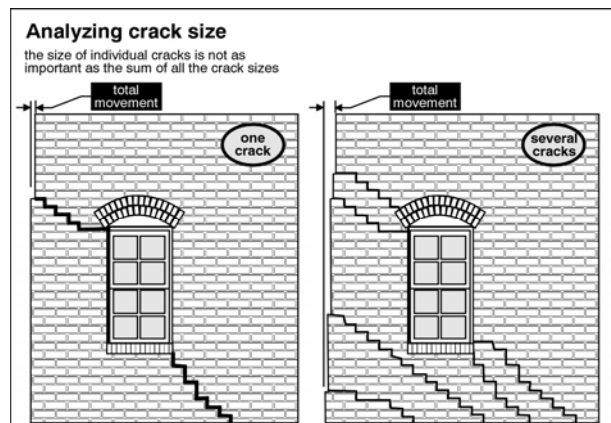
• Exterior Masonry: The exterior brick veneer was visually inspected and based on the inspectors experience; the materials and workmanship are considered to be typical quality for the home building industry. A veneer wall is not structural in the sense that it is supporting the residence, but is a water resistant covering. The wood framing behind the masonry is the main load bearing structural element. Like the interior walls, the masonry walls also reflect any frame and/or foundation movement by cracking. Observation of the exterior masonry may have revealed some cracking to be present. Foundation and frame movement are not the only forces to produce masonry cracking; temperature and moisture also can produce cracks in a masonry wall and both these elements can cause the masonry to expand and contract thereby adding stress to the wall. The conditions observed at the time of inspection appeared to be a combination of these factors; however, the observed conditions did not appear to suggest the presence of a *major* structural problem unless otherwise noted.
